**CONCEPTUAL HABITAT MITIGATION AND MONITORING PLAN  
FOR IMPACTS TO AREAS WITHIN THE JURISDICTION**

**SOUTH ORANGE COUNTY TRANSPORTATION INFRASTRUCTURE  
IMPROVEMENT PROJECT (SOCTIIP)  
ORANGE AND SAN DIEGO COUNTIES, CALIFORNIA**

**August 31, 2007**

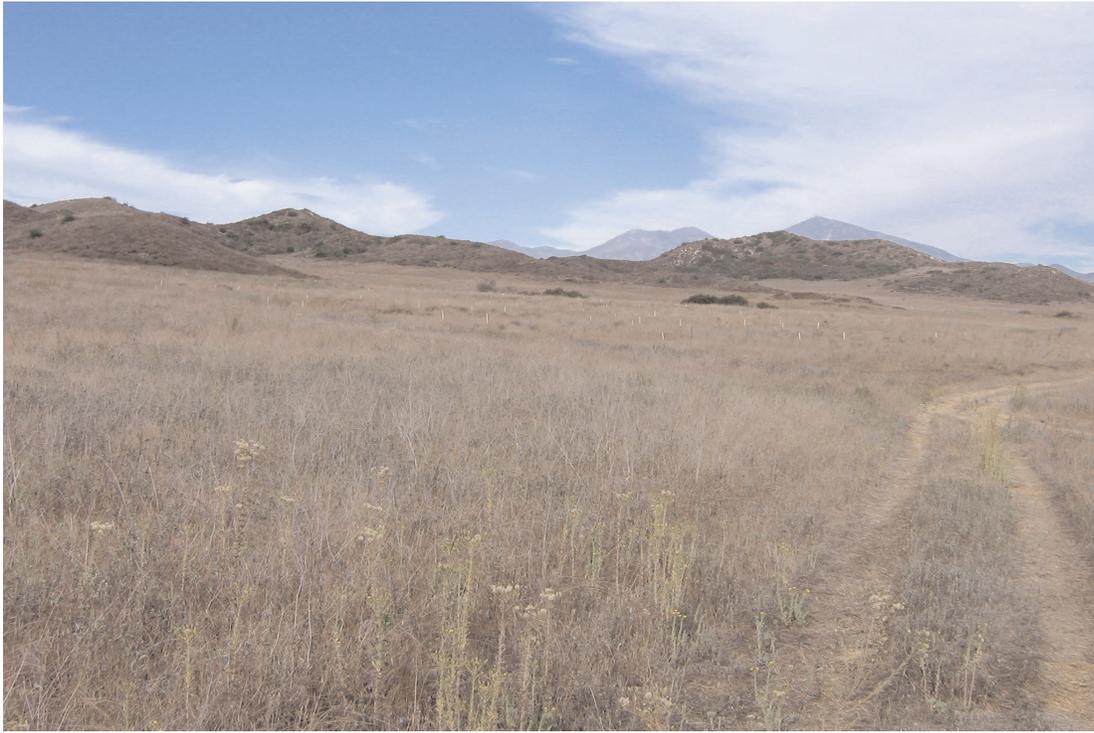
PHOTOGRAPH 1: Representative photo of the native perennial grassland restoration area within the Upper Chiquita Mitigation Area.

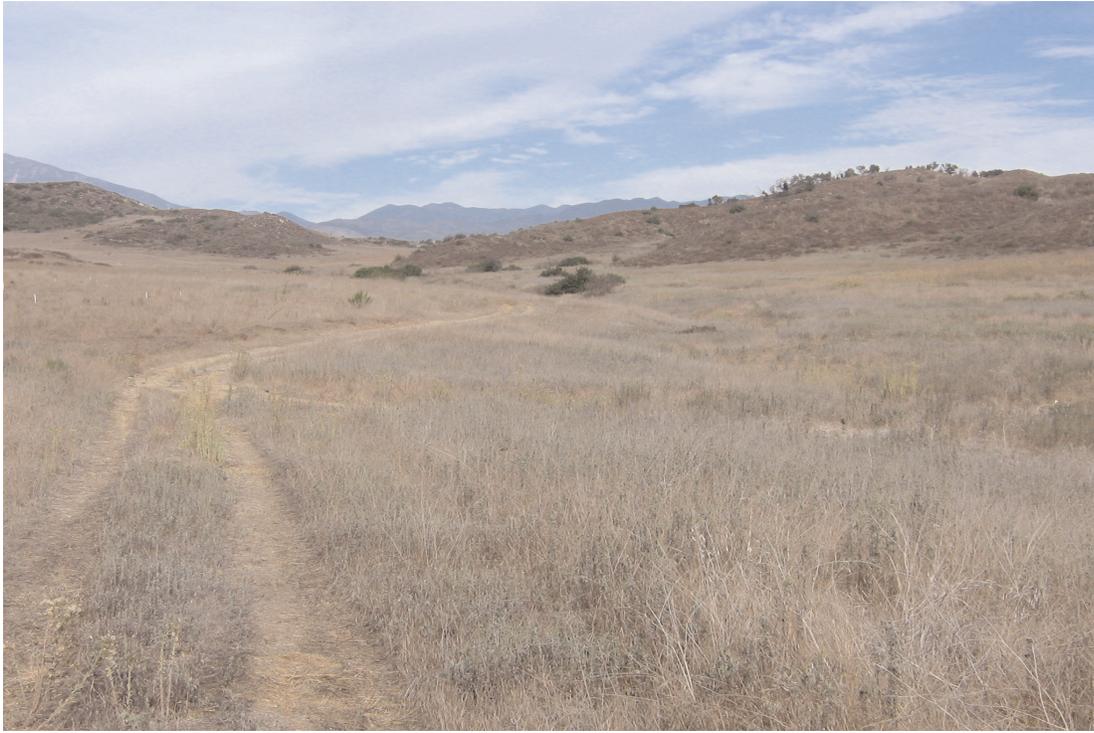
PHOTOGRAPH 2: Looking northeast at the drainages proposed for riparian oak woodland restoration in the distance.

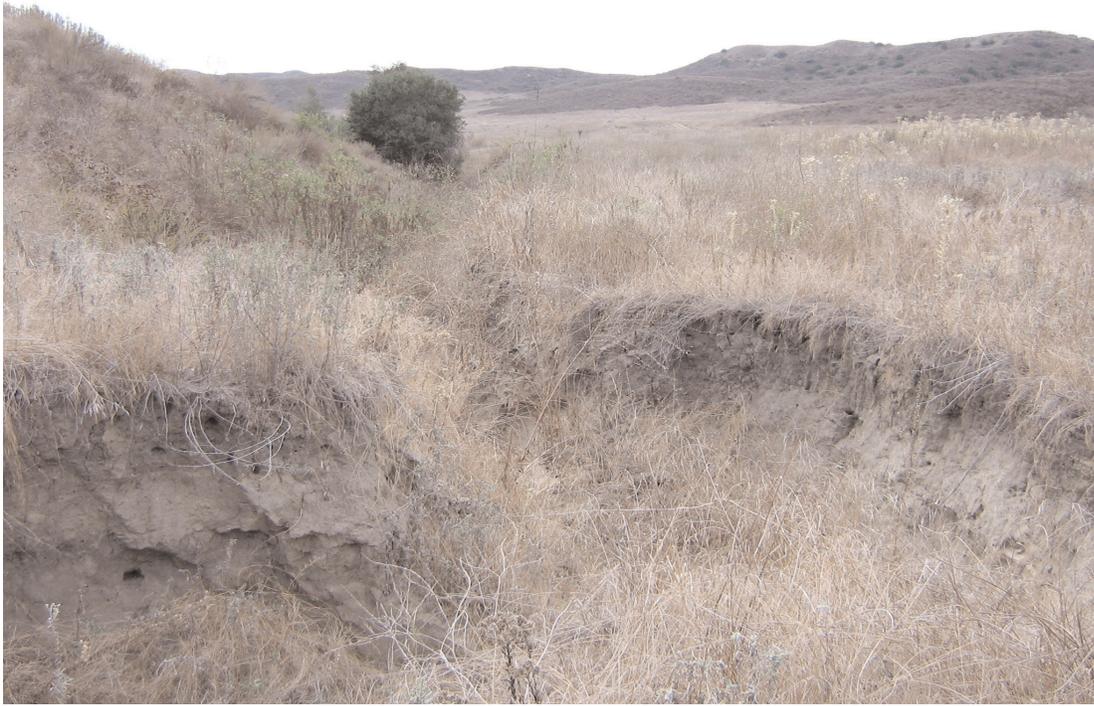
PHOTOGRAPH 3: Representative photo of one the photos proposed for riparian oak woodland restoration.

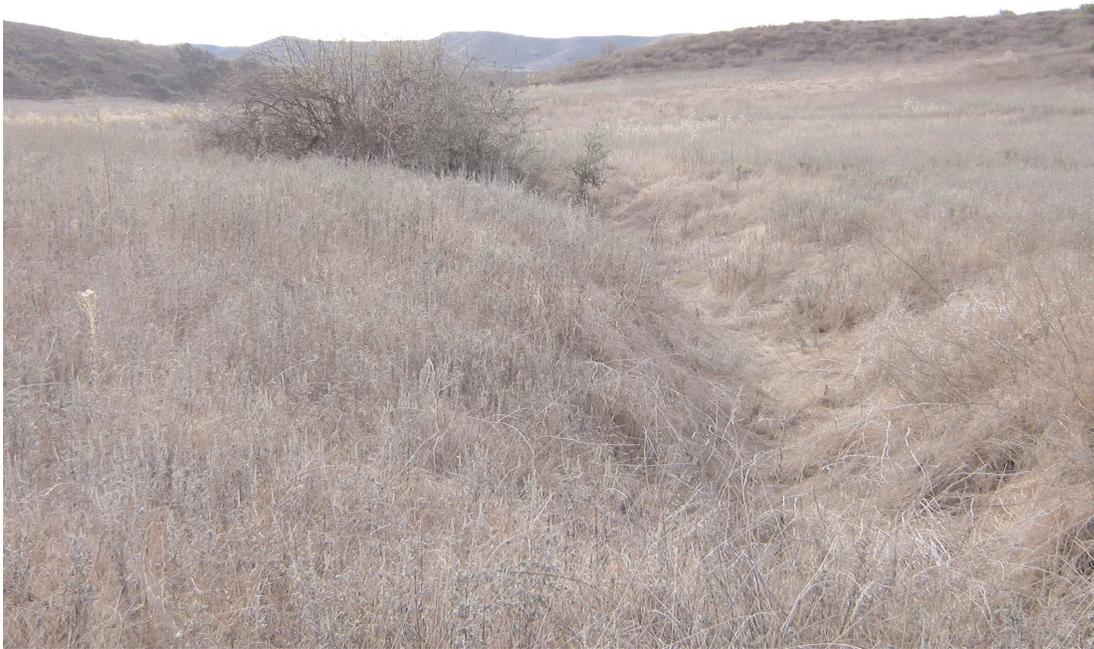
PHOTOGRAPH 4: Looking southwest at one of the drainages proposed for riparian oak woodland restoration.

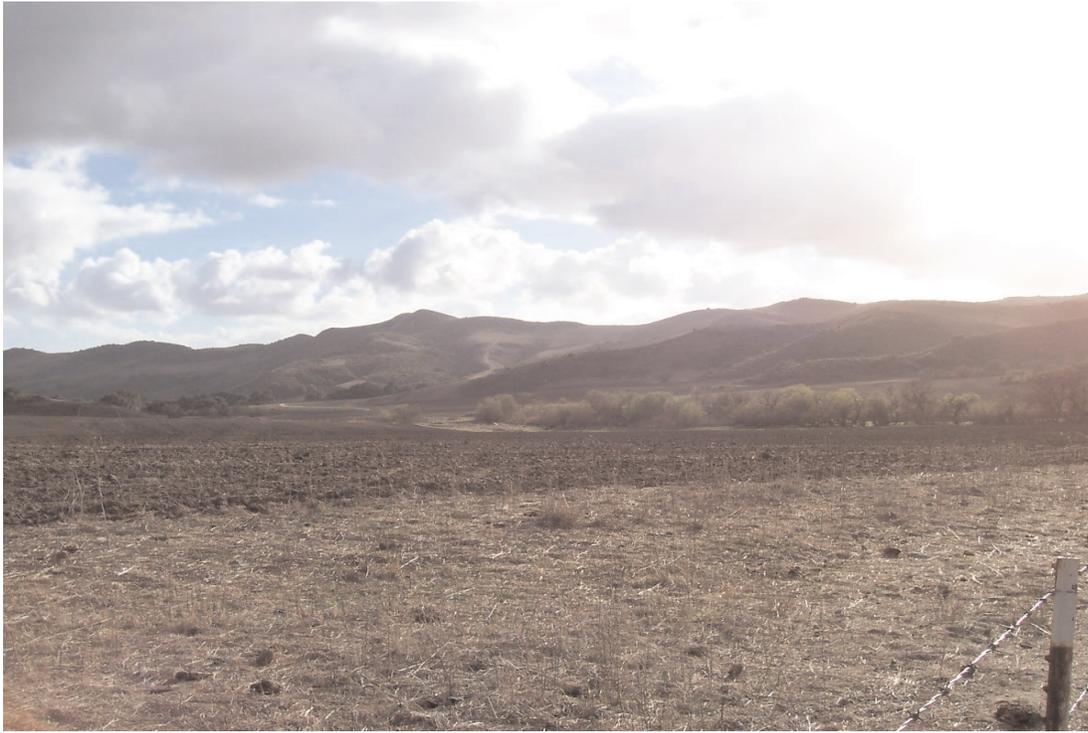
PHOTOGRAPH 5: Representative photo of the Tesoro South Mitigation Area illustrating the existing gap in the riparian canopy proposed for mitigation.

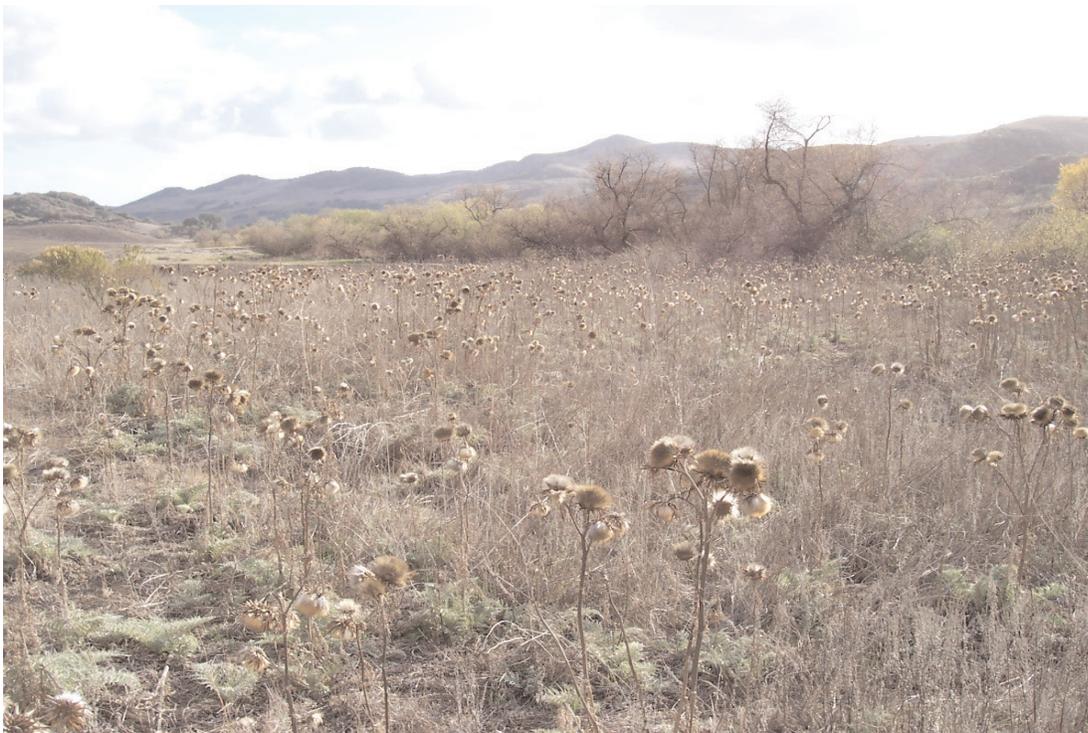
PHOTOGRAPH 6: Looking southwest at the existing riparian vegetation and adjacent non-native, ruderal vegetation proposed for removal within Tesoro South.

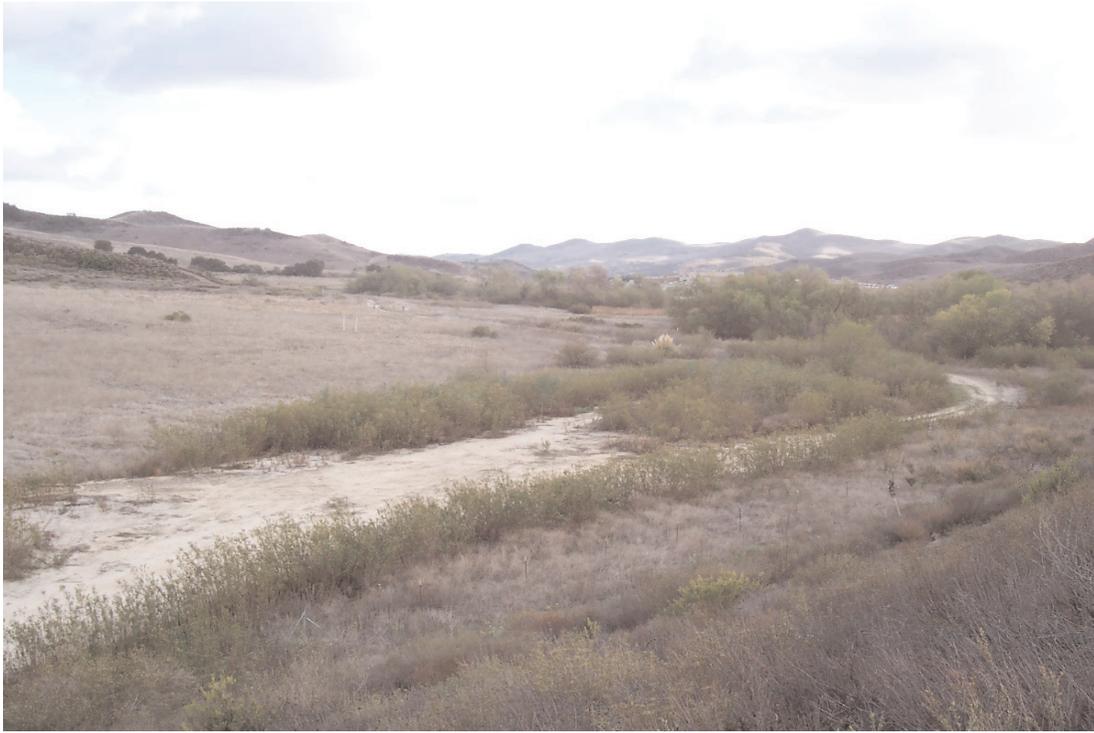
PHOTOGRAPH 7: Representative photo of the Tesoro North Mitigation Area.

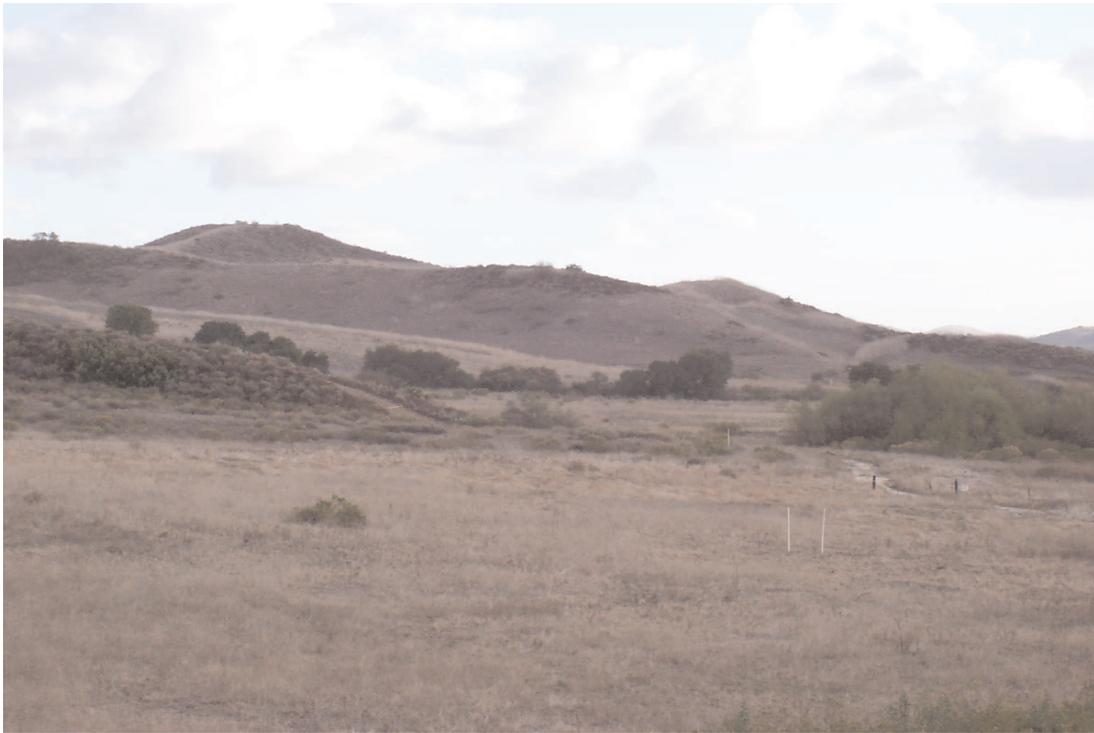
PHOTOGRAPH 8: Looking southeast at the area proposed for oak/elderberry woodland restoration within Tesoro North.

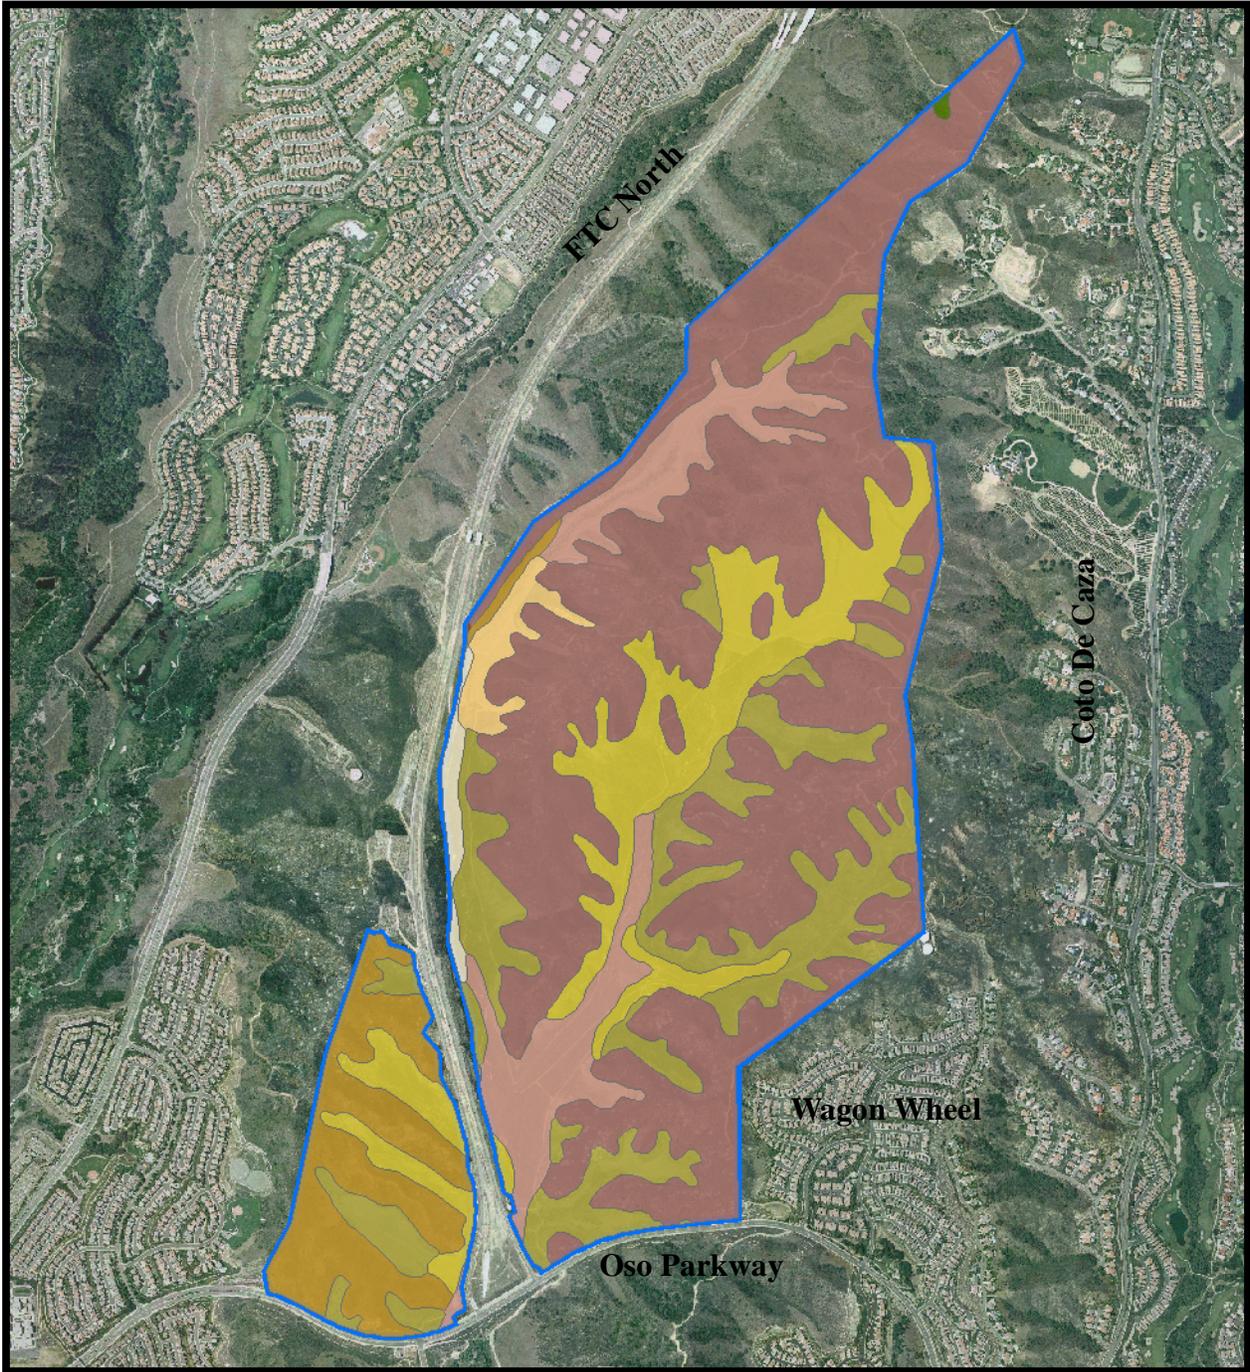
Figure 3

Chiquita Canyon Conservation Area  
Soil Phases

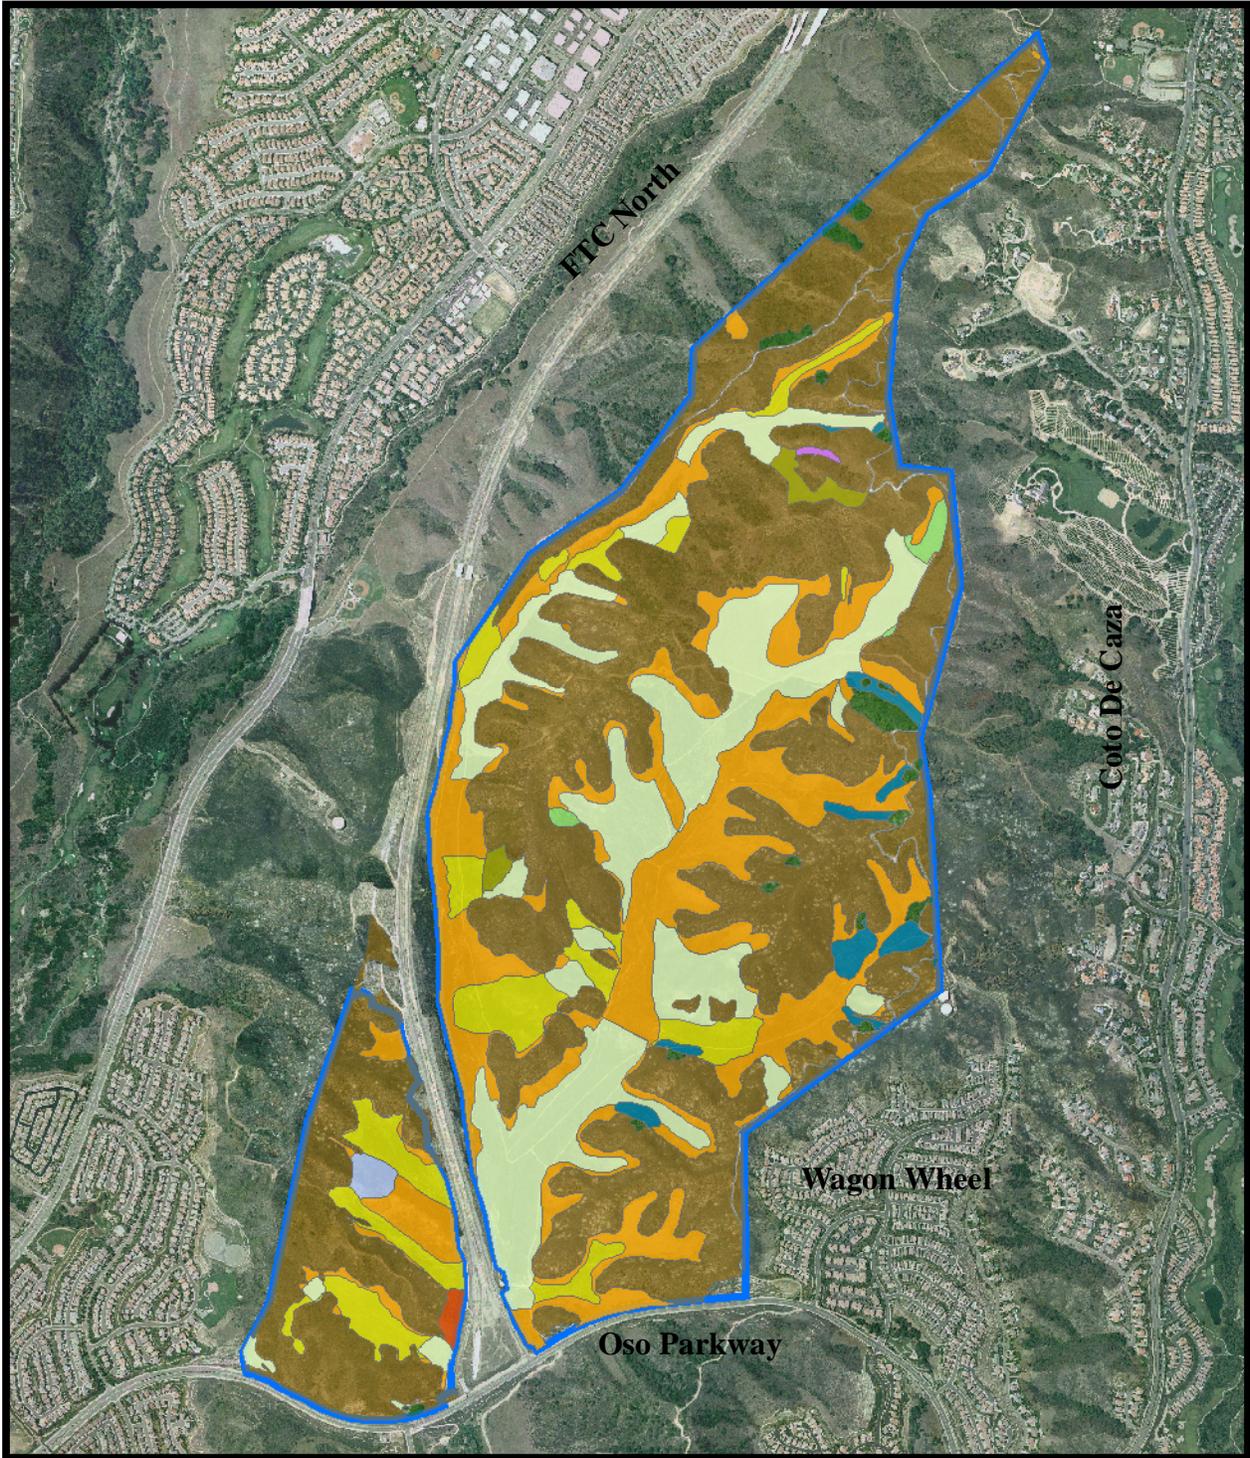
Chiquita Canyon Conservation Area  
 Proposed Habitat Restoration Areas  
 Figure 7

**Table 2. Acreage of Proposed Habitat Restoration in the Conservation Area**

<b>Habitat Type</b>	<b>Acres</b>
Coastal Sage Scrub	241
<i>Coastal Sage Scrub/Perennial Grassland Ecotone</i>	92
Perennial Grassland	182
Oak Woodland/Oak Savannah	31
Native Forb /Native Forb/Perennial Grassland	6
Non-Wetland Water Courses	13

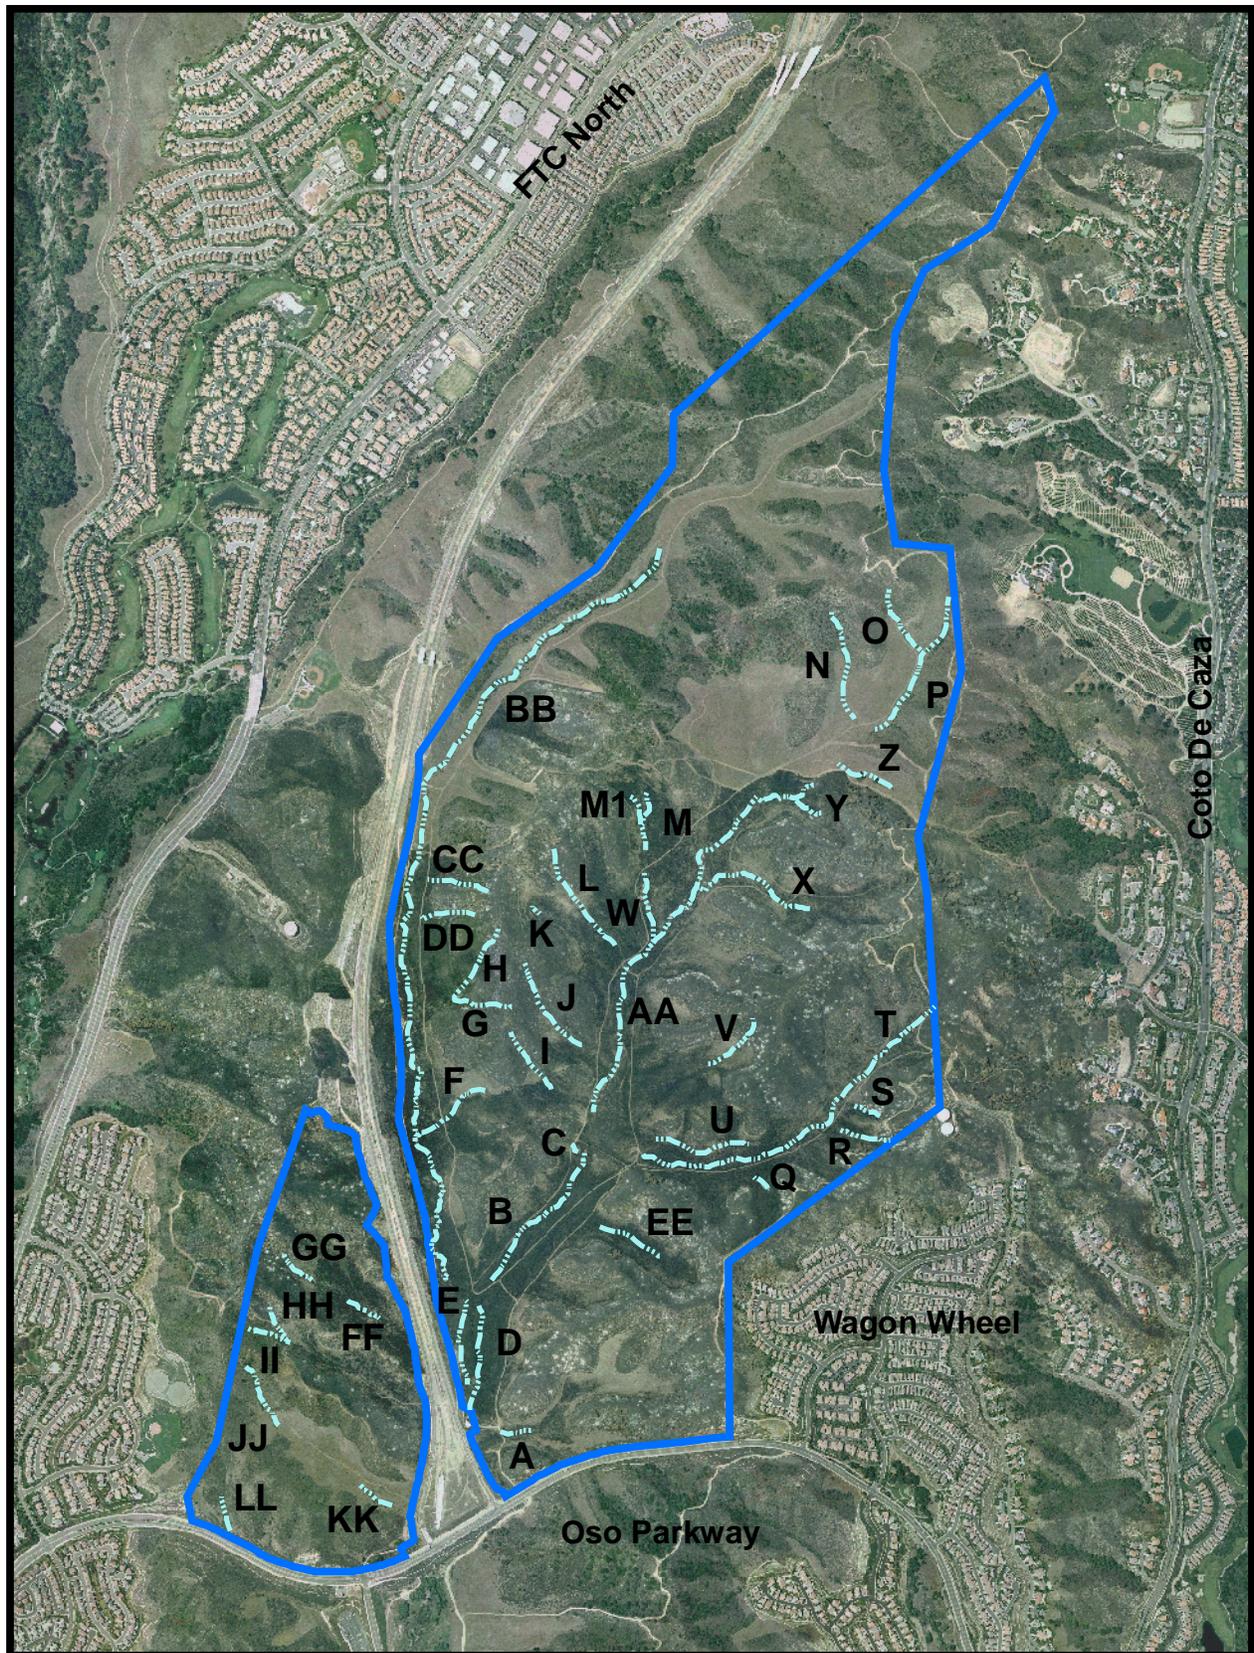
Chiquita Canyon Conservation Area  
Drainages

Landscape location, vegetative cover and morphology of the 38 incised channels varies. Three channels occurring on slopes dominated by native coastal sage scrub species are stable with no evidence of erosion, bank slumping, or sediment filling. Vegetative cover for eight of the channels occurring in valleys is entirely nonnative annual grasses and herbaceous species. The eight incised channels are beginning to fill in with sediment and some of the channels are subject to erosion and bank sloughing. Fifteen channels occurring on slopes are dominated by native coastal sage scrub species for at least half of the reach and by nonnative species as the channels enter the valley. The channels are stable for the section of the reach dominated by native species but are beginning to fill in with sediment and in some channels erosion is occurring in segments of the reach. Twelve channels, eight of which occur in valleys and four on slopes, are surrounded by nonnative grassland but do still have remnant coastal sage scrub species in parts of the reach. The channels occurring in the valleys appear to be subject to more bank cutting, erosion deep incision and head cutting. Bank slumping is also occurring in some of the larger channels.

Four incised channels seem to be negatively effected by a berm located at the Southern end of the Main Canyon. Three of the four channels are occupied solely by nonnative grasses and herbaceous species and the fourth channel has only 50 feet of the 1,450 foot reach covered by native vegetation while the remainder is covered by nonnative grasses and herbaceous species. Upstream the channels are subject to erosion, slumping and head cutting and downstream the channels are filling in with sediment.

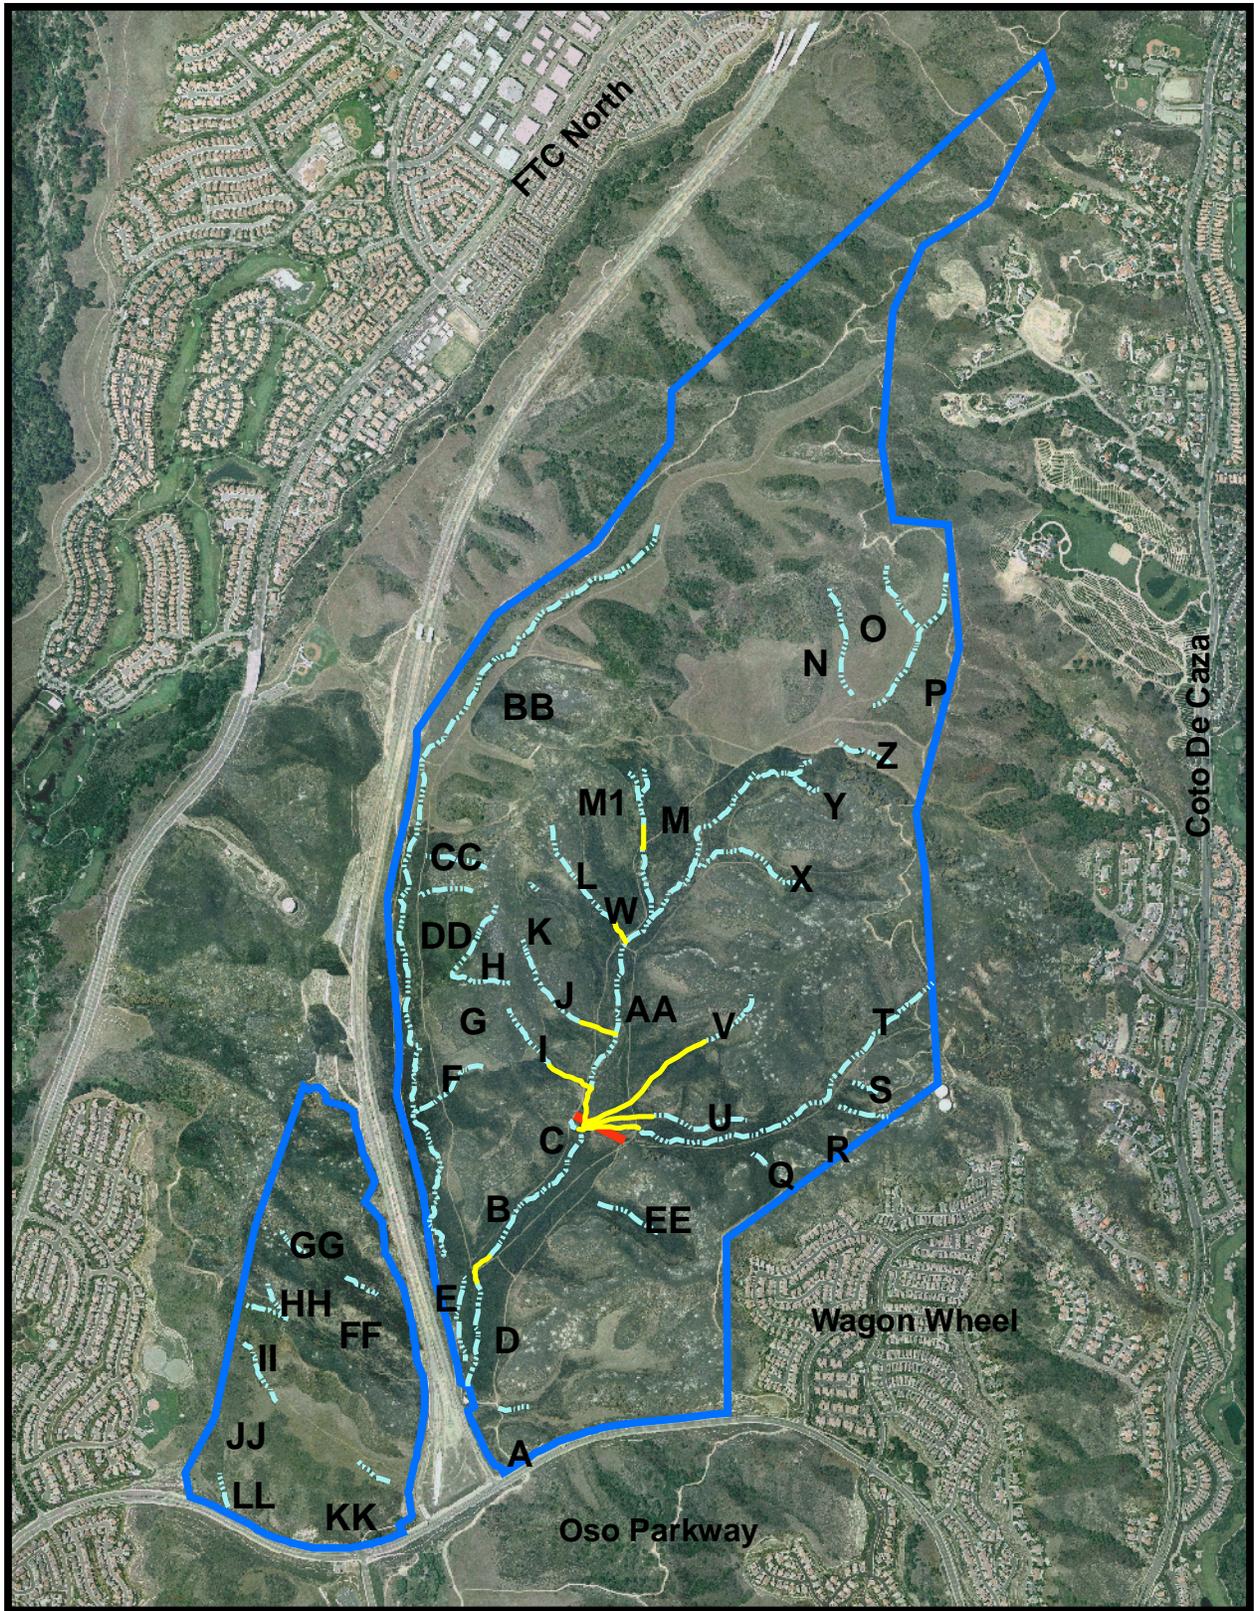
Chiquita Canyon Conservation Area  
Berm Removal

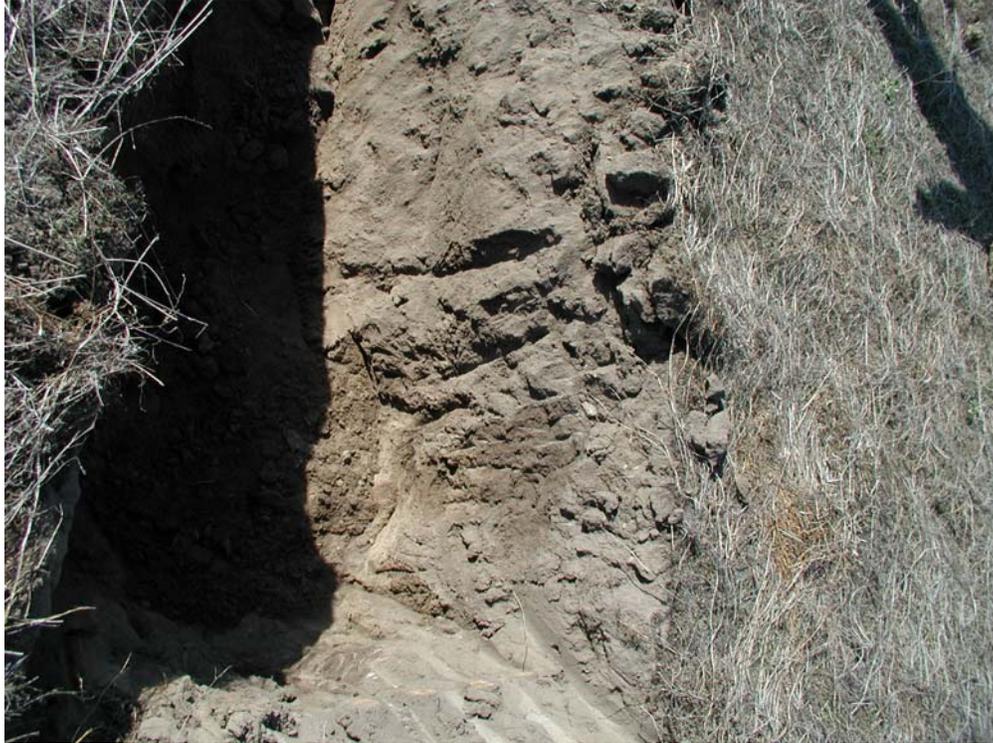
Soil Pit 1 Botella Loam, 2 to 9% Slopes

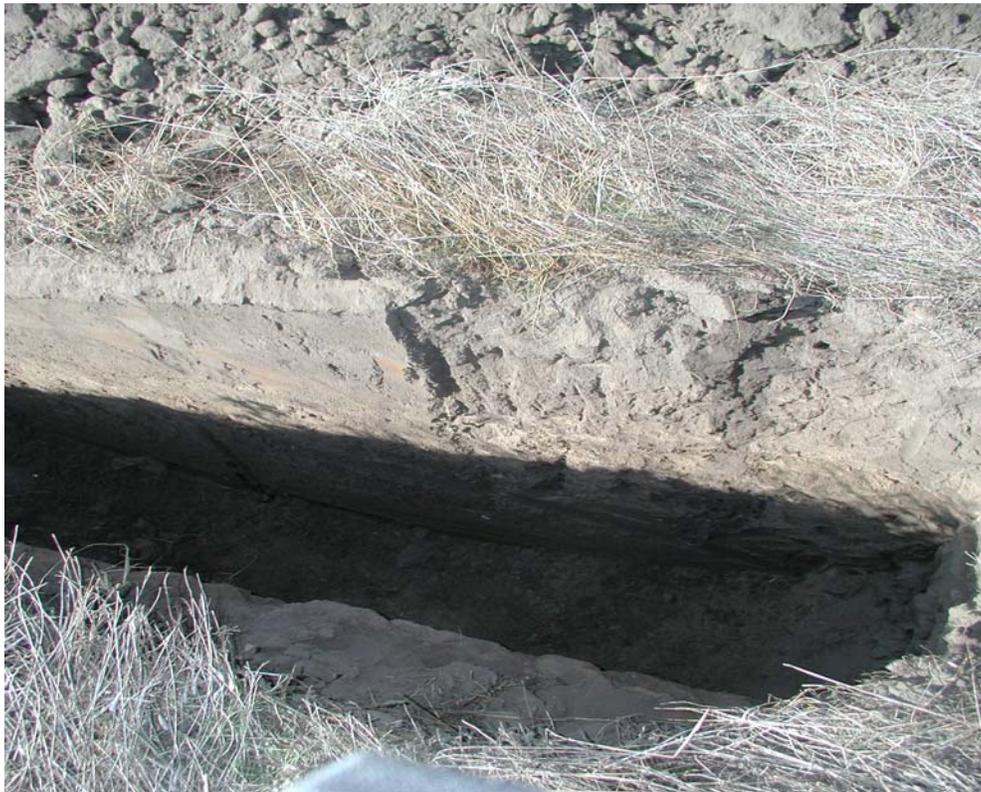
Soil Pit 2 Botella Loam, 2 to 9% Slopes
