RE: Individual Permit Application No. 2000-02170

APPLICATION FOR DEPARTMENT OF ARMY PERMIT

East Sandusky Bay Hydrology Restoration Project:
Application No. 2000-02170 Barnes Nursery, Inc.

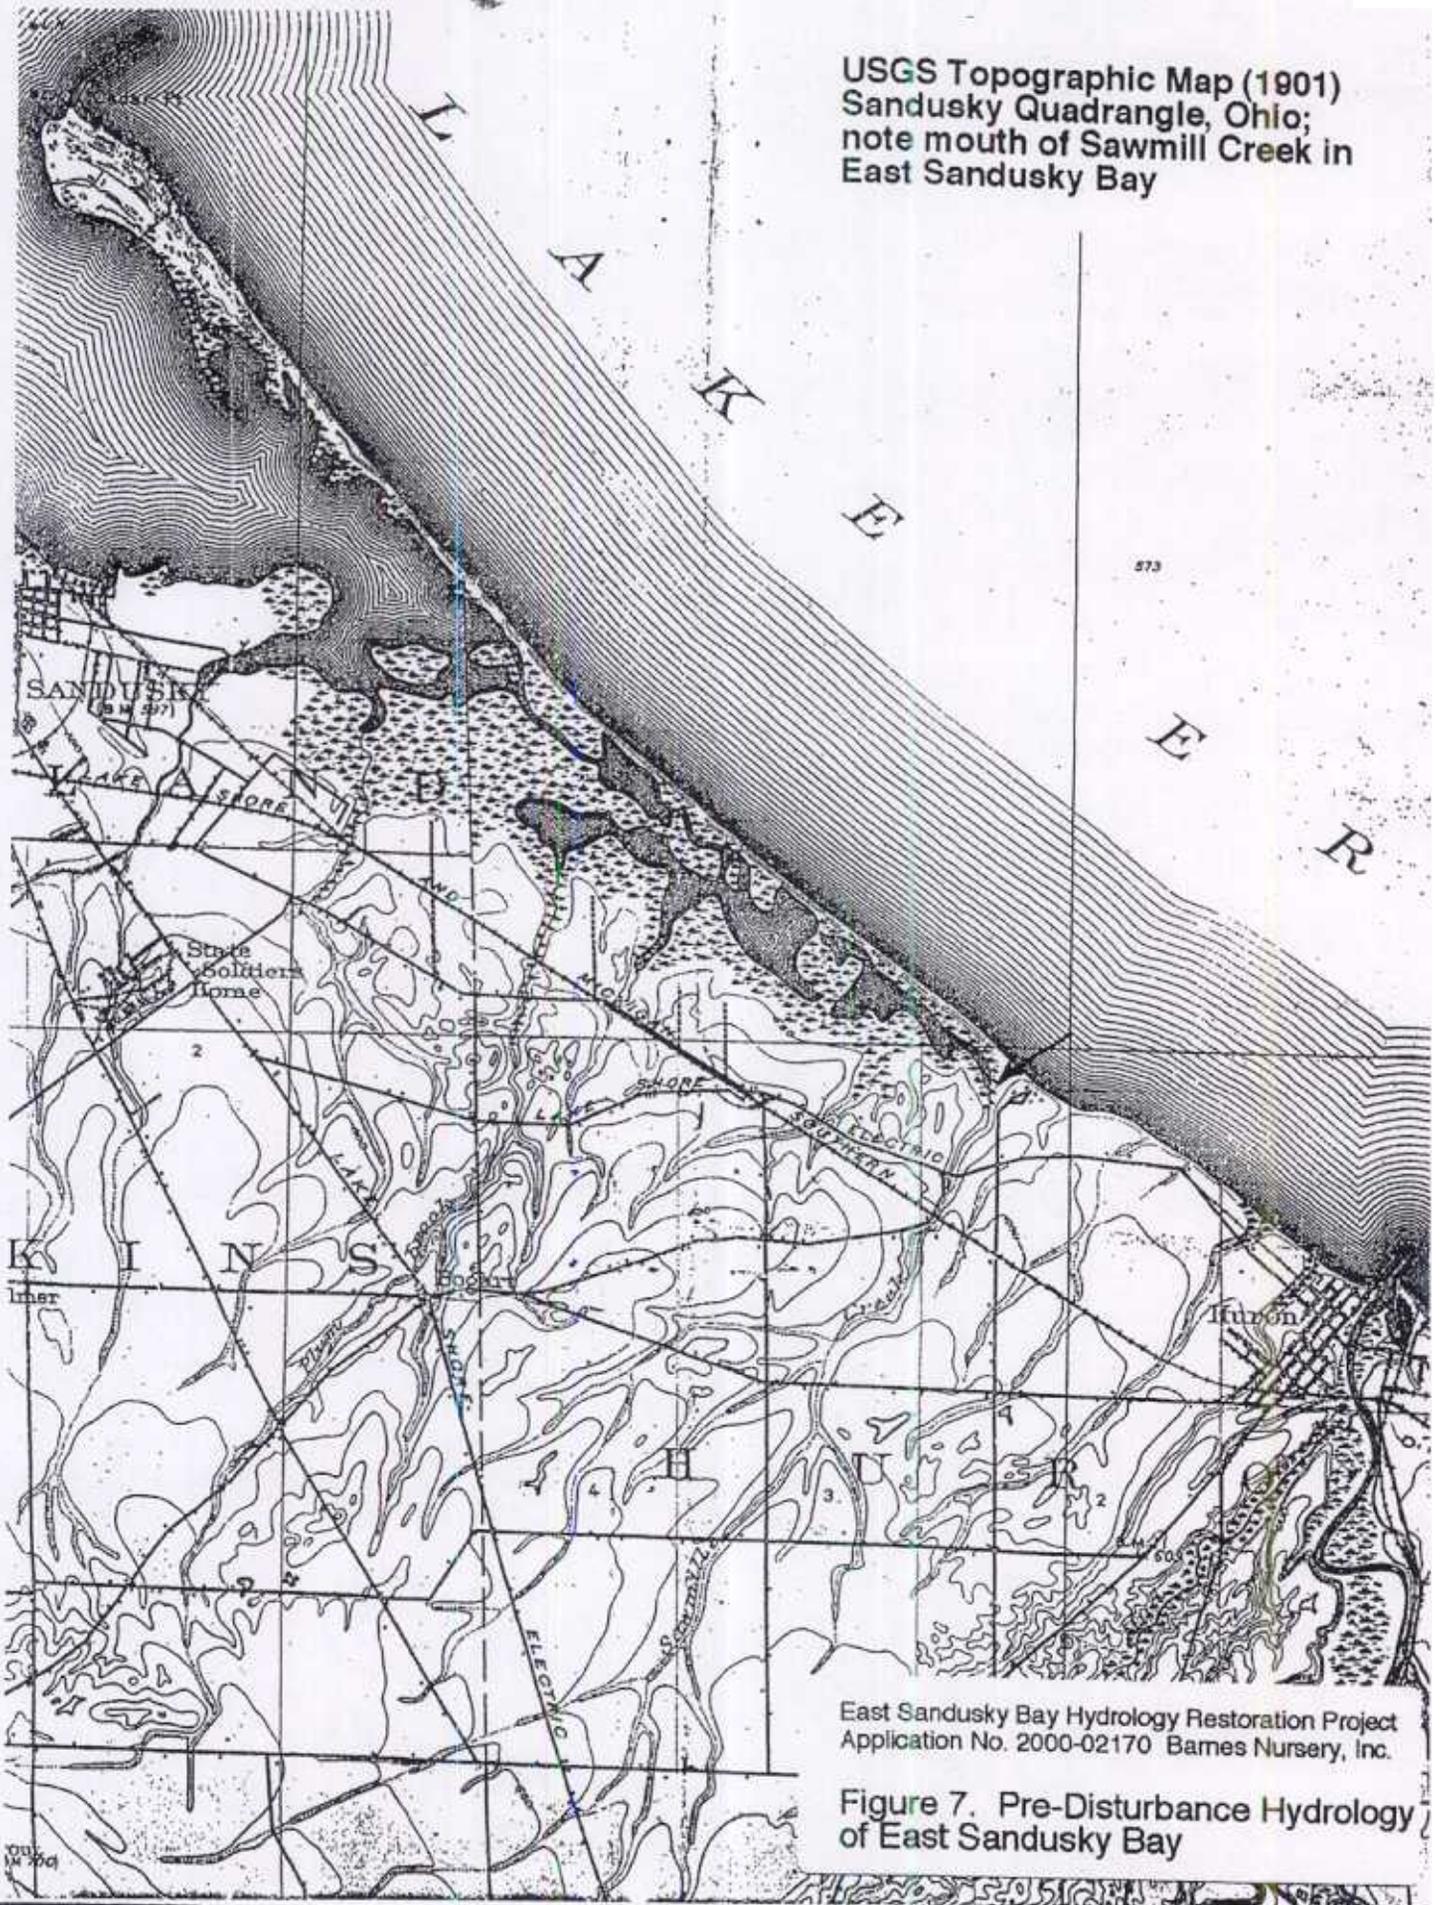
Figure 7. Pre-Disturbance Hydrology
of East Sandusky Bay

USGS Topographic Map (1901)
Sandusky Quadrangle, Ohio;
note mouth of Sawmill Creek in
East Sandusky Bay
